3D LASER SCAN TUNNEL INSPECTIONS KEEP EXPRESSWAY INFRASTRUCTURE PROJECT ON SCHEDULE

PARIS A86 OUTER EXPRESSWAY LOOP

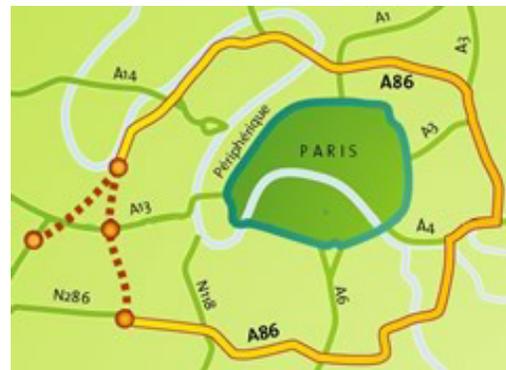
Figure 1: The A86 "missing link".

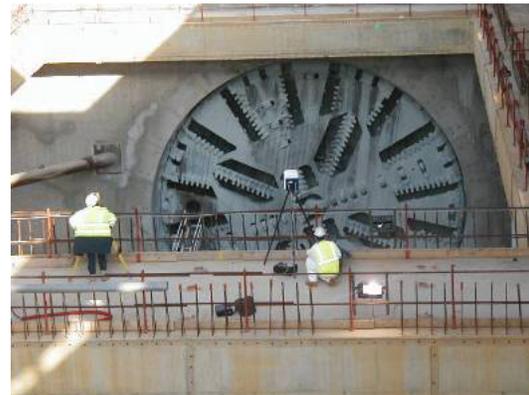
Figure 4: Trimble 3D scanner at work

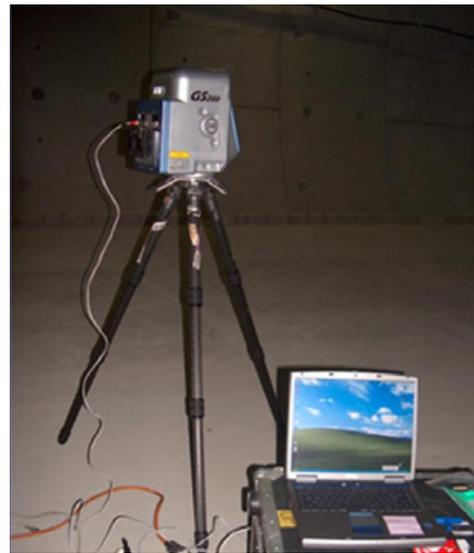
Figure 5: Trimble 3D scanner in tunnel

Given the time constraints and the level of precision that was required in terms of cost control, Socatop immediately decided to use a Trimble 3D scanner. Patrick Gomès-Léal, who was in charge of the survey, commented: "Trimble's 3D scanner was an ideal choice for this tough assignment. We felt sure that laser scanning would significantly increase the speed of operations. A key factor was also the Trimble® RealWorks Survey™ software package, which provided us with highly relevant tools to fulfill critical inspections and analysis."

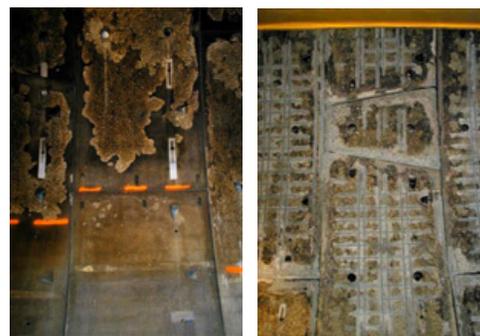
Figure 6a, Figure 6b: damaged areas on concrete liners

The first operation consisted in scanning the full surface area of the tunnel where damage had occurred. Targets were set up as control points in order to conduct surface/volume comparisons after further scans.
